Ballymoney Music Centre
 9th August 2016

CONDITION REPORT

MECHANICAL & ELECTRICAL ENGINEERING SERVICES CONDITION REPORT

BALLYMONEY MUSIC CENTRE

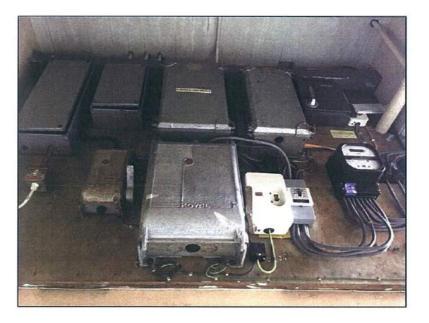
The NIE supply is located on the ground floor in the Entrance Lobby at high level. The electrical supply is three phase with an approximate rating of 50 amps/phase.

There is evidence of a TT earthing facility. The main installation is protected by a TP/N 100mA 100A RCD. There is no evidence of an earth spike.

The existing main switchboard and electrical distribution equipment would be past its useful life expectancy and requires complete replacement.

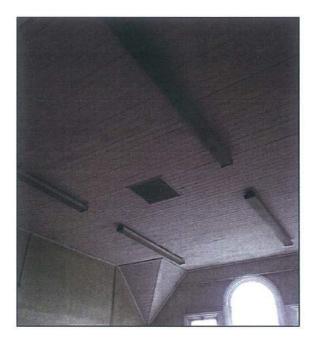
c. Lighting Installation

The lighting within the building is generally surface mounted comprising of switch start linear fluorescents with T12 tubes. The entire existing lighting system is not compliant with modern Lighting Regulations, British Standards and Building Control Regulations.

There is evidence that emergency lighting has been installed within the building however it has a number of deficiencies. These include the following: Wrong legends are installed on exit boxes, some bulkhead luminaires fitted may not meet BS5266, no evidence that bulkhead luminaires are charging the batteries, inadequate coverage generally throughout rooms and stairwells.

The existing lighting installation would require complete replacement to comply with current Lighting Regulations, British Standards and Building Control Regulations. We would note that more aesthetically and architecturally pleasing luminaires are now available in the market place. A new lighting installation would be more efficient and require less maintenance with the use of new lamp technologies, such as L.E.D., with presence detection and daylight sensing.

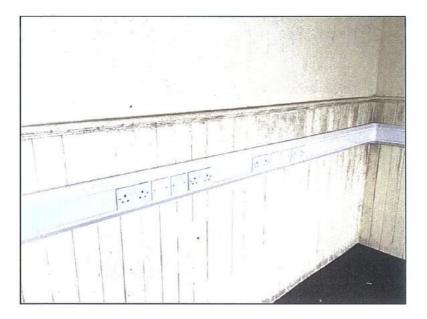
d. General Purpose Power and Data Installations

There are socket outlets installed at various locations in the buildings. In general socket outlets are installed in PVC dado on ring circuits. These circuits are not protected by 30mAmp MCB/RCD's. There are also dedicated electrical supplies to water heaters and other miscellaneous items of equipment.

The existing communications (data) installation is not suitable for modern high speed equipment which requires high data transfer speeds.

It is recommended that the existing general purpose power and data installations are at the end of their useful life cycle.

A replacement system would incorporate sufficient additional socket outlets to facilitate all known current and future power connection requirements.

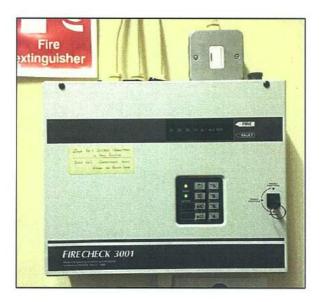
e. Fire Alarm Installation

A fire alarm system is currently installed within the building. The system is manufactured by Tann Model Firecheck 3001. The system comprises of breakglass units at final exits and fire bells. There is no fire detection equipment located in the escape routes. It would be necessary to provide a fire alarm system to comply with the current British standards, such a system would provide fire protection to those using the building as well as protecting the property in the event of a fire.

It is considered essential that a new fire alarm system is installed to protect the entire building. We recommend that a fire alarm system be installed in accordance with BS5839-1:2013 and subsequent amendments, and be to a minimum L3 standard, but more advisable to an L1 standard which covers all areas throughout the building. An L3 system is designed to give a warning of fire at an early stage to enable all occupants, other than those in the room of fire origin, to escape safely, before the escape routes are impassable owing to the presence of fire or smoke. Such a fire alarm system would be provided with strobe/sounders for the visually impaired and should be centrally monitored which again would offer a higher standard of protection than currently exists to both property and life.

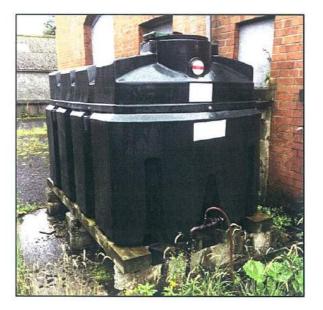
c. External Oil Storage

The external oil tank is a plastic bunded tank and has a capacity of 2500 litres. The tank is in good condition and meets with current building control regulations. The external oil distribution pipework is in extremely poor condition.
