## Template for Requesting Speaking Rights at the Planning Committee

Planning Ref:
 LA01/2020/0631/O

Structural Survey of Building at 168 Agivey Road, Coleraine.

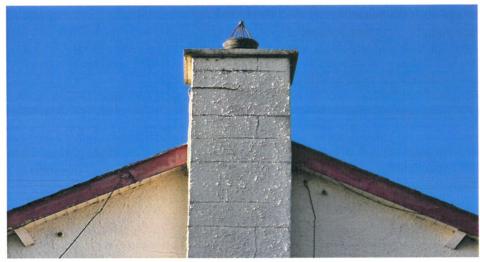
The chimney stack on the east elevation has a number of cracks.

Photo 2 – Cracking at External Chimney

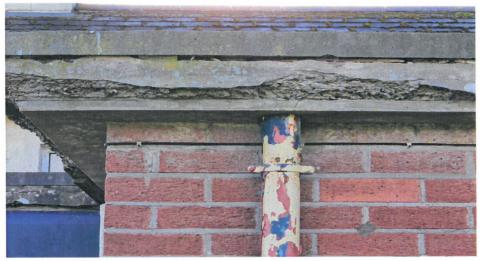
Externally the walls appear to be generally in good condition even though they do not meet structural standards set in the Northern Ireland Building Regulations. There is a damp proof course installed in the walls but it is at a lower level than is acceptable by today's standards. The pitched roof is covered with tiles which appear to be asbestos, the flat roof is a concrete slab which exhibits significant spalling.

Photo 3 – Spalling of flat roof slab

- The roof of the ancillary accommodation needs replaced and the walls need significant repair. Combine this with the DPC being inadequate and the walls not being insulated then it would be economically and practically more sensible to demolish this section of the building.

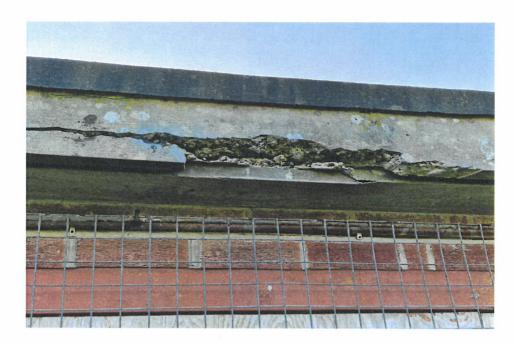
Photo 4 – Spalling of flat roof slab

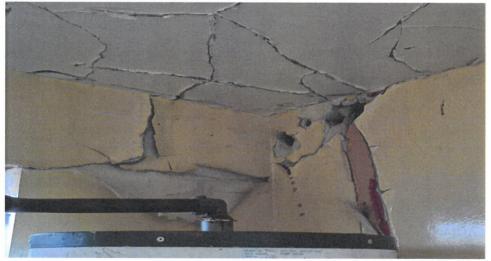
The internal walls of the building are in varying states of repair, the walls in the ancillary building exhibits significant internal cracking which can be classified between Category 1 and 3 in the BRE scale.

Photo 5 – Internal Cracking

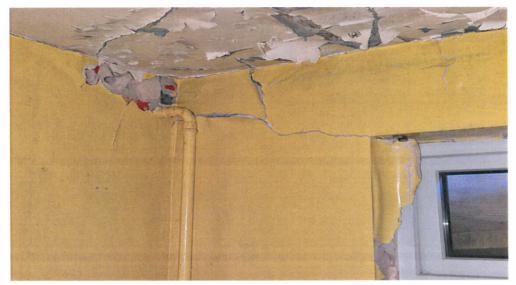
Photo 6 – Internal Cracking

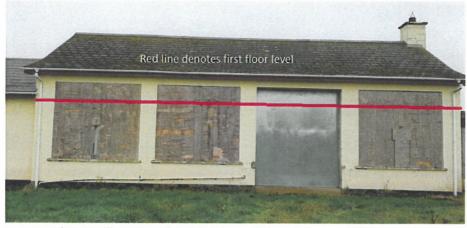
- The position of the windows would clash with a new floor structure meaning that the existing window openings would need to be altered structurally to lower the lintel level.

Photo 7 – Illustration of clash between existing windows and 1<sup>st</sup> floor level

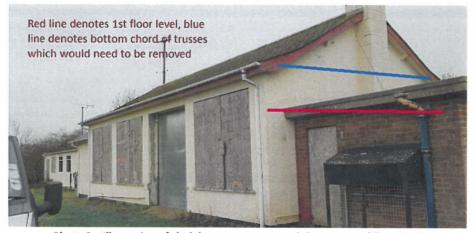
- The bottom chord of the trusses would need to be removed to create adequate head height for a new first floor. This would remove the triangulation in the roof structure and result in a requirement for relatively major structural work to maintain stability of the roof.

Photo 8 – Illustration of clash between trusses and clear space 1<sup>st</sup> floor level
