Ballysally Youth & Community Centre	10th October 2017
To: The Leisure & Development Committee For Decision

Re: Inspection and Condition Survey of Ballysally Community Centre

SCHEDULE OF CONDITION

**Ballysally Youth &
Community Centre
Ballysally Road
Coleraine
BT52 2QA**

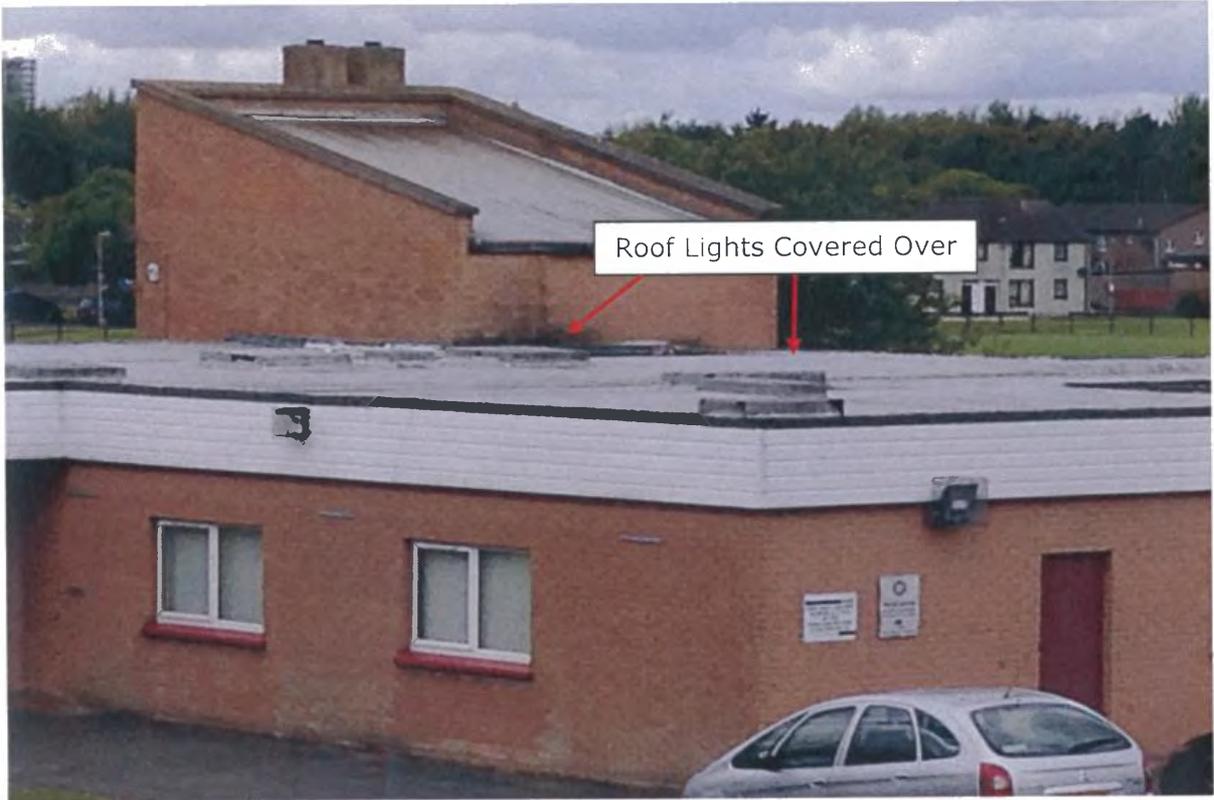
Photo 3

Roof coverings appear to be of the membrane type generally although a small section of roof to the front right hand corner is mineral felt. Considerable ponding of water was noted on the mineral felt roof. Elsewhere a number of roof light upstands appear to have been made redundant by covering over in membrane (photograph 3).

No structural issues were noted during the inspection. The ponding on the roof should be addressed before it causes problems.
