DUNLUCE AVENUE TOILET BLOCK, PORTRUSH	7th February 2017
TO: ENVIRONMENTAL SERVICES COMMITTEE	
FOR DECISION

CONDITION SURVEY REPORT

**AMENITY BLOCK
DUNLUCE AVENUE
PORTRUSH**

for
CAUSEWAY COAST + GLENS BOROUGH COUNCIL

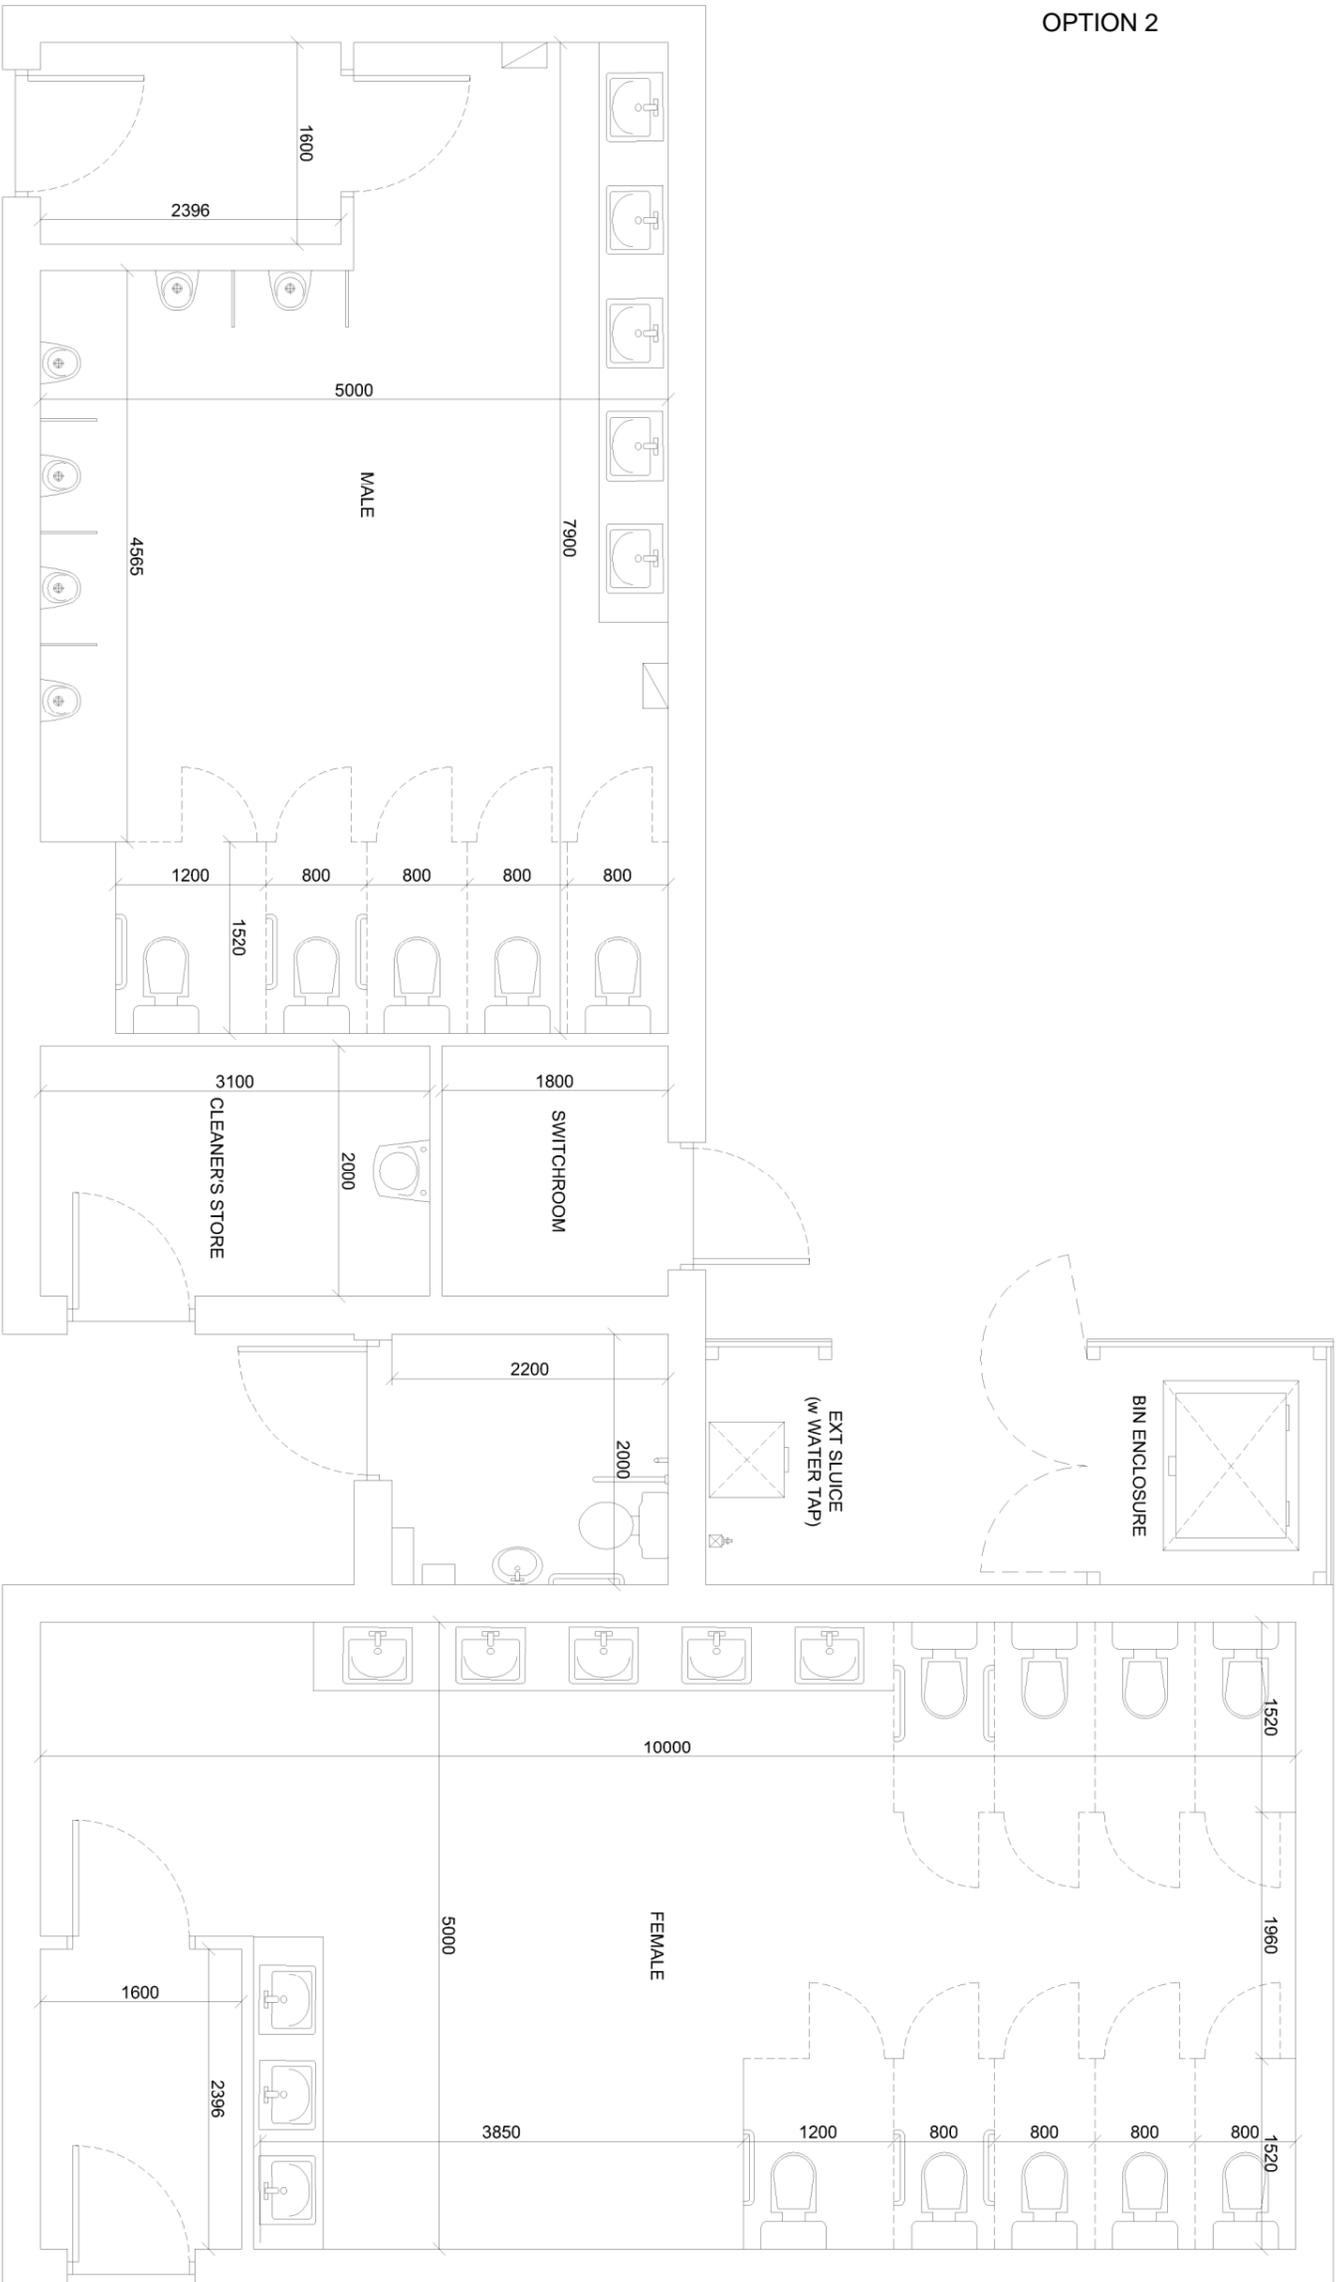
OPTION 2

EXTERNAL WALLS: GAULT BLOCKWORK
 ROOF: TIMBER TRUSS WITH INSULATION AND
 SINGLE PLY MEMBRANE COVERING
 FLOOR: GROUND BEARING CONCRETE SLAB
 WINDOWS: ROOFLIGHTS DOUBLE GLAZED PVC
 ALUMINIUM UNITS

**THIS DRAWING IS AN INDICATIVE
 CONCEPT SKETCH FOR ILLUSTRATIVE
 PURPOSES ONLY.**
